PROFILE MEASUREMENTS OF PORTLAND CEMENT CONCRETE TEST SLAB AT
THE NATIONAL AIRPORT PAVEMENT TEST FACILITY

By:
Wayne Marsey
FAA Airport Technology R&D Branch, AAR-410
William J. Hughes Technical Center
Atlantic City International Airport, NJ 08405
USA
Phone: (609) 485-5297; Fax: (609) 485-4845
Wayne.Marsey@faa.gov

PRESENTED FOR THE
2004 FAA WORLDWIDE AIRPORT TECHNOLOGY TRANSFER CONFERENCE
Atlantic City, New Jersey, USA

April 2004

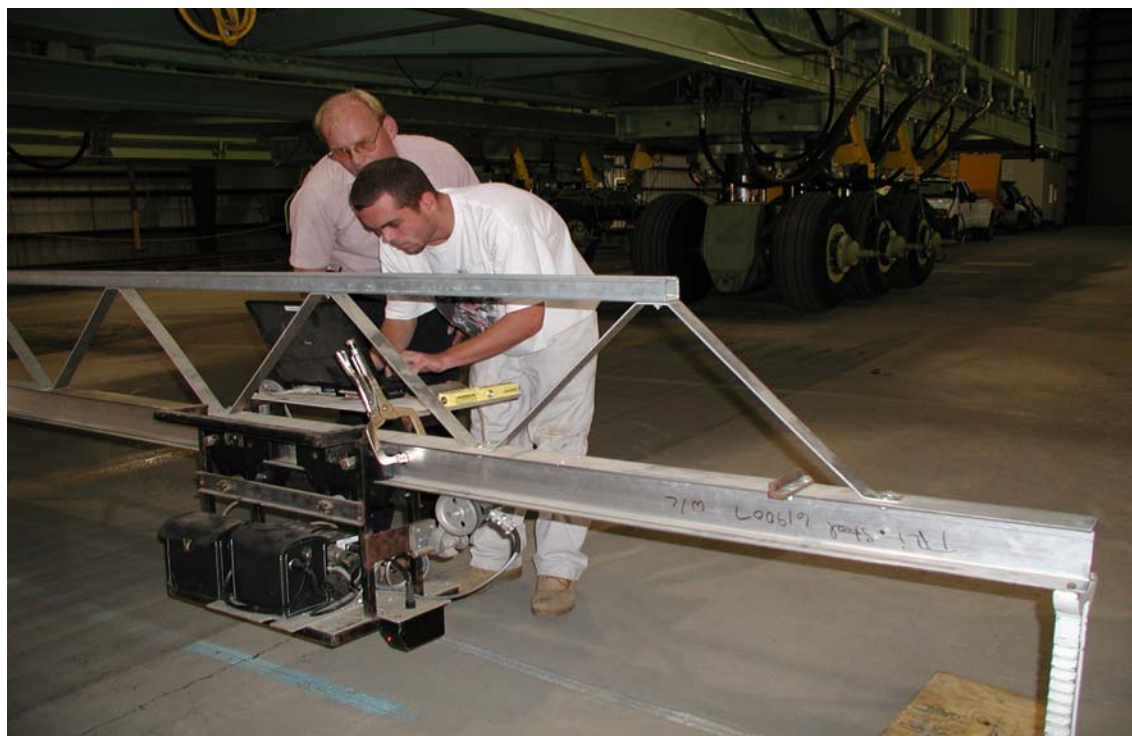
Figure 2. FAA pavement profiling device at NAPTF.

The current configuration of the FAA pavement surface profiling device consists of a vertical displacement transducer, an incremental rotary encoder, a data acquisition box, and a laptop personal computer. The profiling equipment is mounted on a trolley that rolls along the flange of an aluminum beam 24 ft (7.3 m) long, as shown in Figures 1 and 2. The beam has a steel top member for reinforcement and stability.

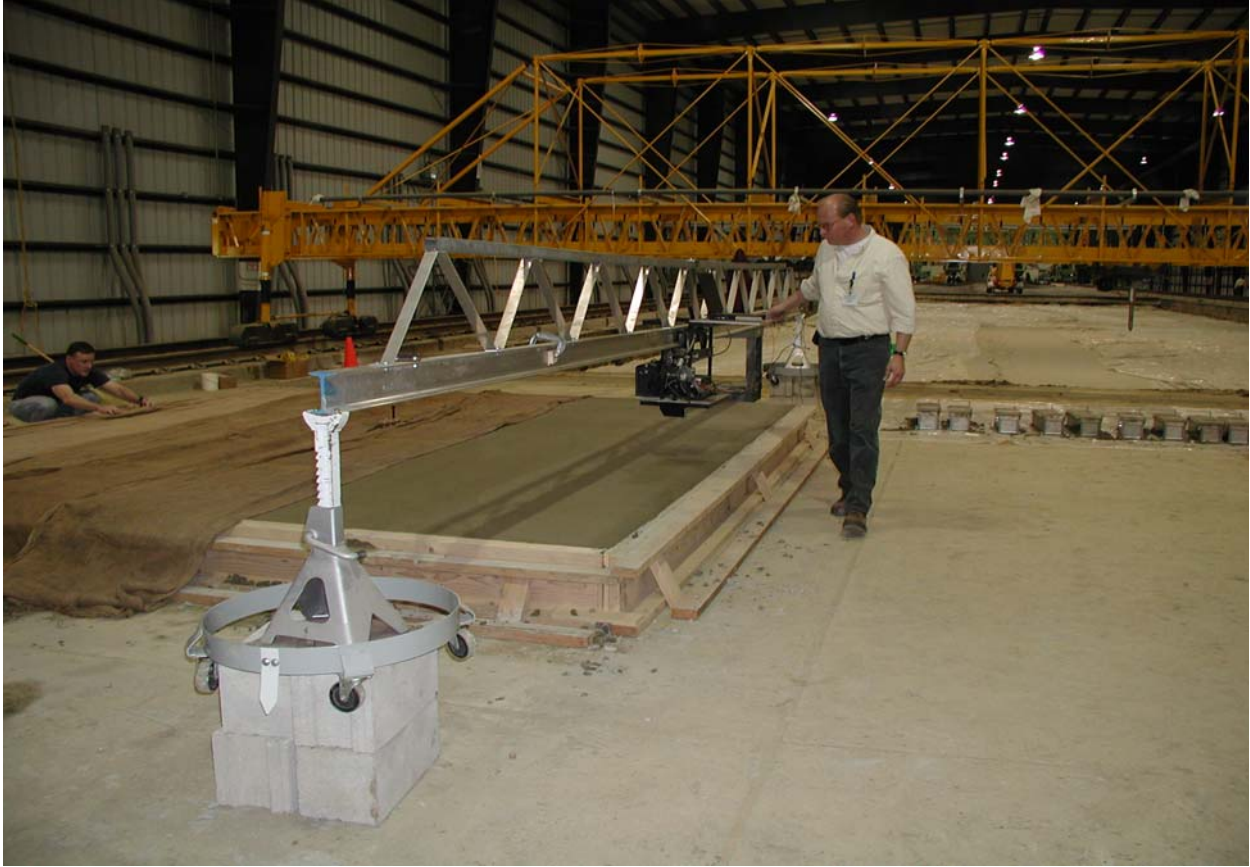
Figure 5. Data collection with FAA pavement surface profiling device.

Figure 5 shows personnel collecting the profile data with the FAA pavement surface profiling device. Note the early age of the test slab by the forms not yet removed. The test slab was kept wet during the early age (the 28 day curing process) by covering the test slab and soaking the burlap.
